STEEEDA

2013+ Focus ST Intake

Manifold Spacer

Instructions for parts #555-3183 & 555-3184

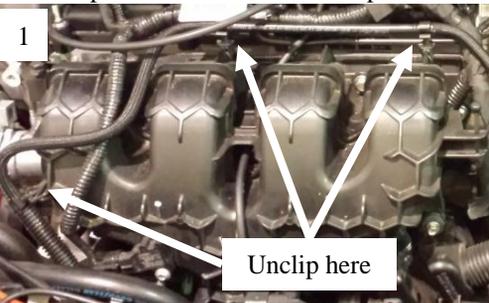
1. Remove the engine cover by gently pulling up on the cover around the corners.
2. Carefully, remove the line from the three clips on the intake manifold. See figure 1.
3. Disconnect the MAP sensor located on the passenger side of the intake manifold. See figure 2.
4. Disconnect the sending unit from the behind the manifold. See figure 2.
5. Remove the 5 bolts holding the intake manifold on. See figure 3

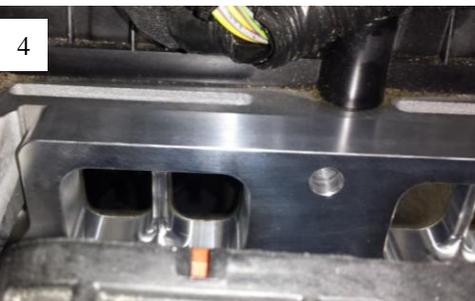
6. Carefully pull back on the manifold, just enough to slide the spacer into location. The o-rings on the spacer will go towards the engine. Make sure the two alignment pins fit into the unthreaded holes in the head. See figure 4.
7. Re-align the manifold on the spacer, and install the supplied M8 bolts, with one washer needed per bolt. Tighten the bolts.
8. Reconnect the MAP sensor and sending unit. Reinstall the line into the clips on the manifold.
9. Verify that everything is tightened and plugged in. Complete.

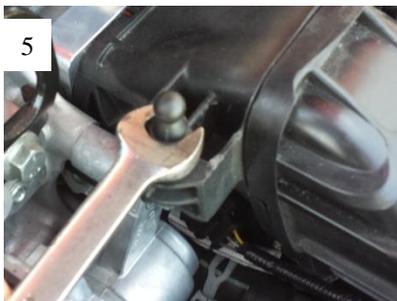
1. Using a 13mm wrench, loosen and remove the ball stud that is threaded into the passenger side of the intake manifold. See figure 5.
2. Fasten the provided ball stud to the bracket with the supplied jam nut, using a 13mm and 10mm wrench or sockets.
3. Insert the Christmas tree clip into the bracket, and place the washer on the backside of the bracket.
4. Push the Christmas tree clip into the hole where the original ball stud was. Be sure the clip is pushed in completely. See figure 6.
