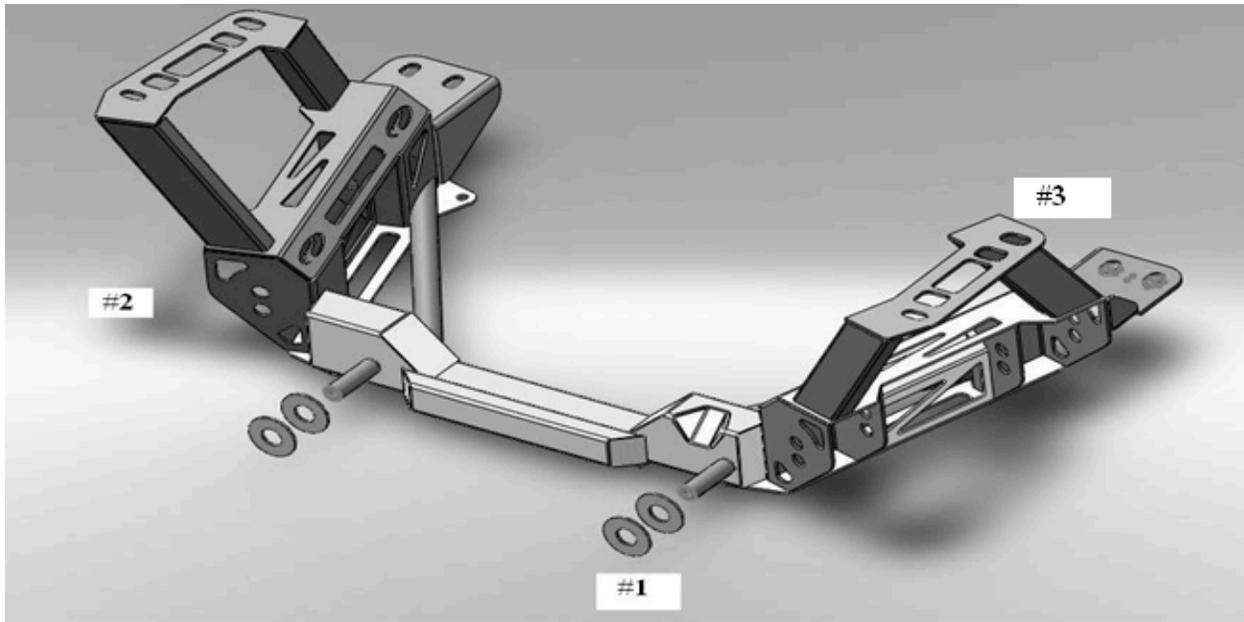
When mounting the steering rack and pinion to the K-Member, use the 4 zinc coated, supplied washers as shown in the figure above. When installing the washers, their placement in front of or behind the steering rack and pinion will alter the factory steering Ackerman. For factory Ackerman, mount both of the washers behind the rack and pinion. For non-factory settings (predominately for vehicles lowered more than one-half inch), place the washers with one on each side of the rack and pinion or both in front of the rack and pinion to correct steering Ackerman. Also note that if using one or two of the washers in front of the steering rack and pinion it is important to turn the factory steering rack and pinion washer around to prevent it from becoming flattened upon tightening.
